## PROJECT PACIFIC SEA SPIDER

### Technology Used in Developing a Deep-Ocean Ultrastable Platform

JOHN B. GREGORY

OFFICE OF NAVAL RESEARCH  
DEPARTMENT OF THE NAVY  
Arlington, Virginia

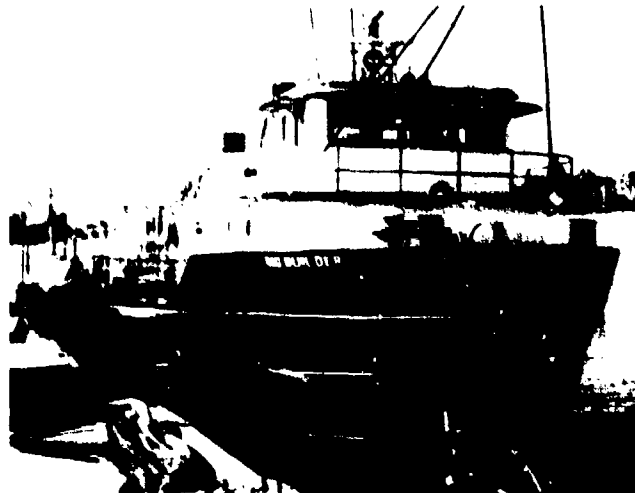
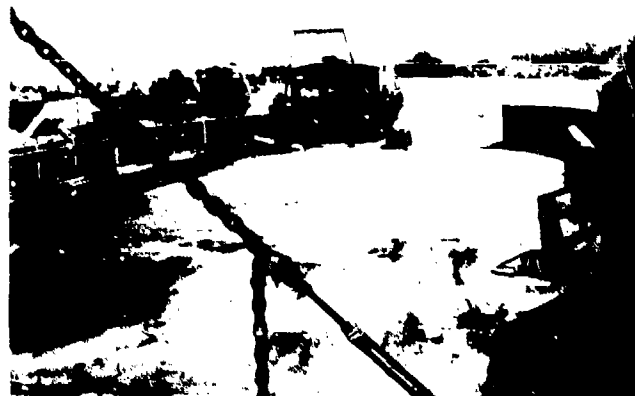
(U) Fig. 2 — Two views of the implantment vessel,  
*Rigbuilder*, prior to project outfitting

(U) The weight of the moor and equipment necessary to complete its implantment was over 400 tons; almost all of this hardware was carried aboard the implantment vessel, *Rigbuilder*, a 165-foot offshore supply boat (Fig. 2). This type of vessel was selected because of its large open main deck, high power, maneuverability, and stability. In addition to this rather unconventional use of a supply boat, unusual means for paying out cable were employed wherein overhead power cable-tensioning winches were used to lay cables and to lower anchor crown lines. The implanting of Sea Spider was neither a conventional mooring operation nor a cable-laying task; it was a specialized deep-ocean implantment of a complex tensioned structure.

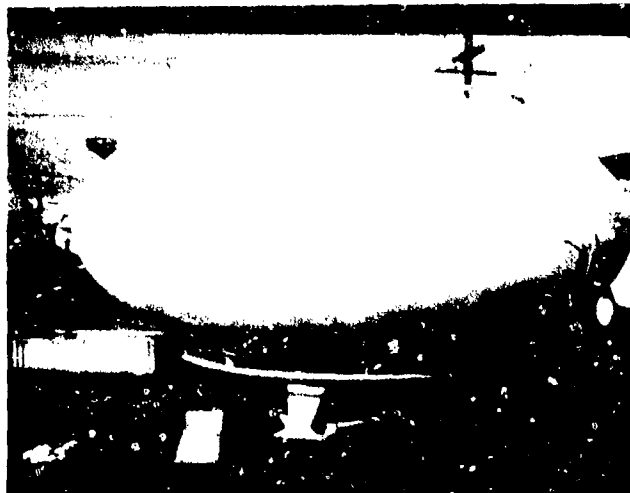
(U) Fig. 3 — Subsurface buoy in its deck transporting cradle with diver ladder and handrails visible including a circular handrail at the bottom.

(U) The buoy (Fig. 3) was an oblate spheroid 14-1/2 feet in diameter and 7 feet high with a comparatively low hydrodynamic drag. Together with its electronic canisters and three 3400-pound radioisotope thermoelectric generators, it provided a net buoyancy of 26,000 pounds. Its weight in air also was 26,000 pounds. Its design internal and external pressure was 200 psig and 150 psig respectively. The buoy was built of 6061-T6 aluminum alloy and subsequently tested hydrostatically to 100 psig. Alloy 6061 was selected because of its well-established resistance to corrosion. However aluminum alloy 5086 was preferred but not available within schedule limitations.

(U) A vertical cylindrical tube or tunnel, which extended completely through one of the voids and was open to the water at each end (next to the ladder in Fig. 3), was provided as a receptical for a self-powered acoustic transponder. The transponder was mounted so that its transducer projected through the underside of the buoy for purposes of locating the buoy when submerged or on the surface. A vessel attempting to locate the buoy would have been provided a portable interrogator for signaling the transponder.

(U) The buoy was designed to be lifted from three lifting lugs symmetrically positioned near the center (behind the offcenter hatch in Fig. 3). On the lugs a removable bracket or yoke was bolted for a single-point lift. Another pad eye was welded to the side of the buoy for towing. The buoy was observed to tow at speeds up to 7 knots without significant yaw or pitch. Underneath the buoy a low-profile, tripodlike cradle (Fig. 3) was bolted to the buoy and to the deck of the implant vessel.

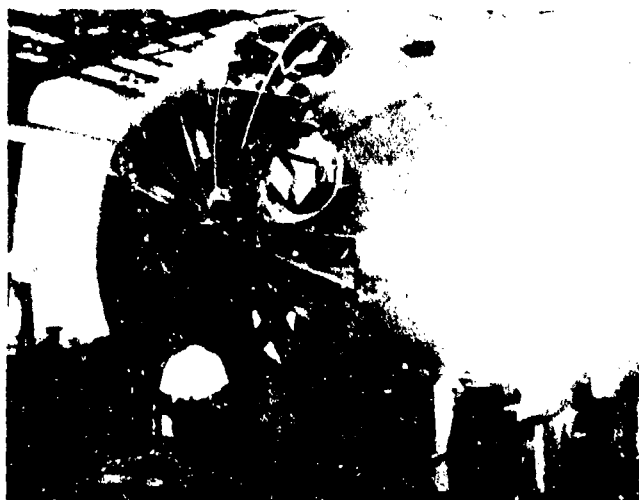
(U) Fig. 4 — Construction views of the subsurface buoy showing a loading hatch (top photo), the large central compartment (bottom photo), and wing tanks

(U) As shown in Fig. 4 the buoy contained nine peripheral pressure-proof wing tanks or voids surrounding the central electronic and power-supply compartment. The voids and the central compartment were pressurized for the implantment depth by means of manifolded piping inside the center compartment of the buoy. Bulkhead stop valves located between the manifold and each individual void were closed to isolate each in case of damage. A remote-reading bourdon-tube pressure gage was located underneath the buoy to enable divers to determine and equalize the ambient and buoy pressure before opening the hatch.

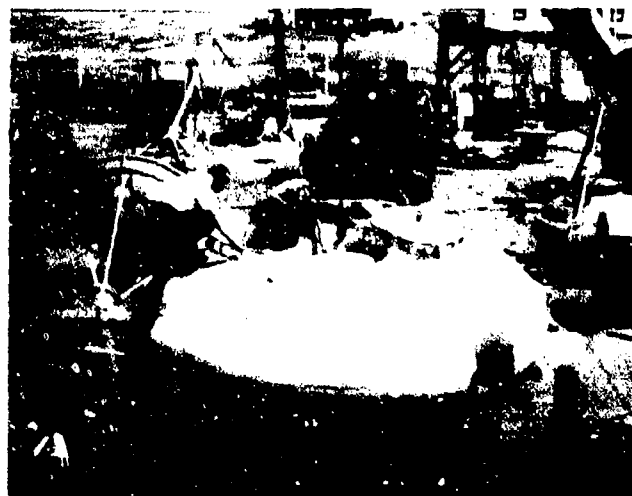
(U) Fig. 5 — Subsurface buoy during loading of the radioactive thermoelectric generators. The hatch cover is not visible; the cover next to the handrail is a faring plate to go over the hatch cover.

(U) The surface telemetry buoy, which is at the left in Fig. 5, and also shown in Fig. 8, was a 7-foot-diameter ellipsoid built of foam-filled fiberglass. In the buoy was a well in which was inserted a canister containing VHF and UHF radio transmitters and a command receiver. A tripod mounted on top of the buoy supported a fiberglass mast for HF telemetry with a smaller antenna affixed above it for VHF telemetry. This small antenna worked loose in the rough seas during the first implant attempt and was not used thereafter. Instead a VHF antenna was fiberglassed to the side of the mast. At the base of the mast, just above the tripod a box containing an antenna coupler may be seen (Fig. 8). A second tripod, inverted underneath the buoy, and having lead ballast disks clamped to its apex, may be seen in Fig. 5 and 9. Also seen under the buoy is a copper electrical grounding plate. The buoy was designed to roll not greater than 30 degrees in state 5 seas so as to preclude antenna dropout. Visual observations during the implantments verify this stability was attainable even when the elastic tether was not attached.

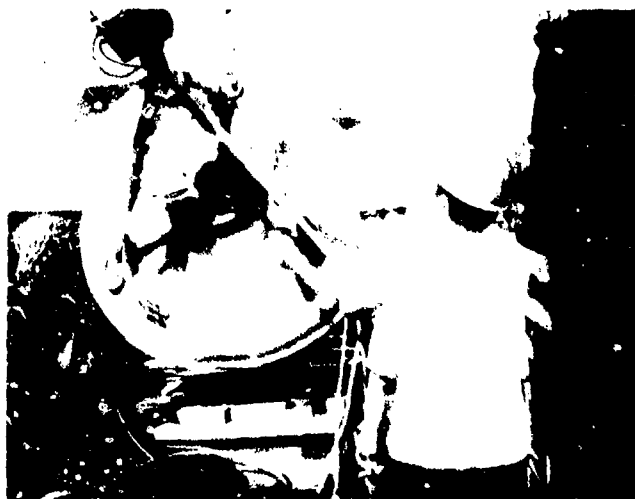
(U) Fig. 8 — Surface telemetry buoy. The upper photo shows the tripod mast support, radar reflector, and antenna tuner box. The lower photo shows the transmitter canister in the foreground.

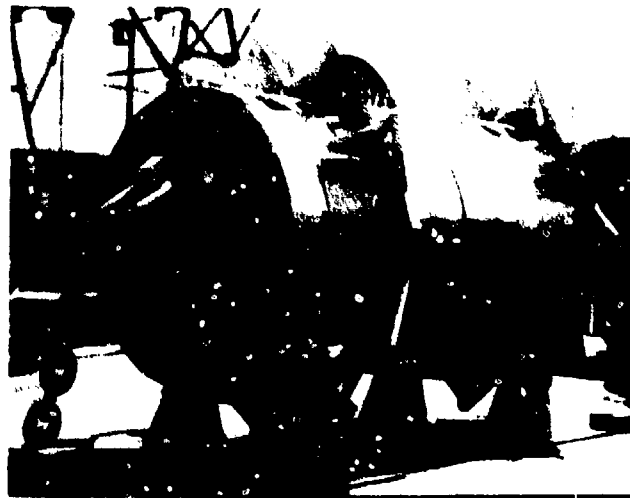
(U) Fig. 10 — Anchor for one of the three legs

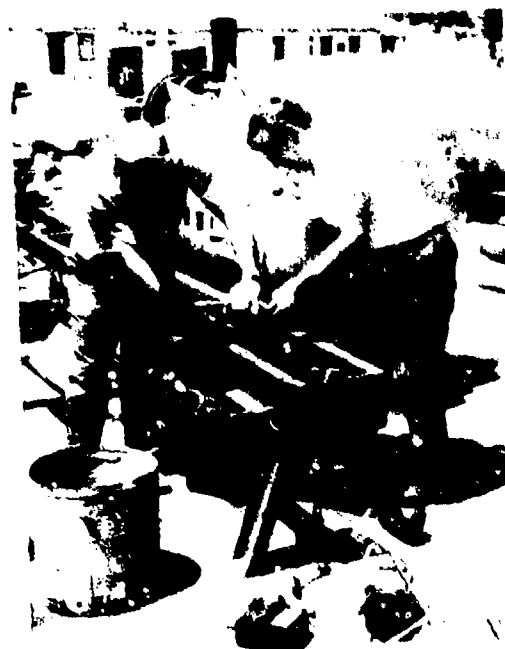
(U) Fig. 12 — Mechanical termination during assembly and test

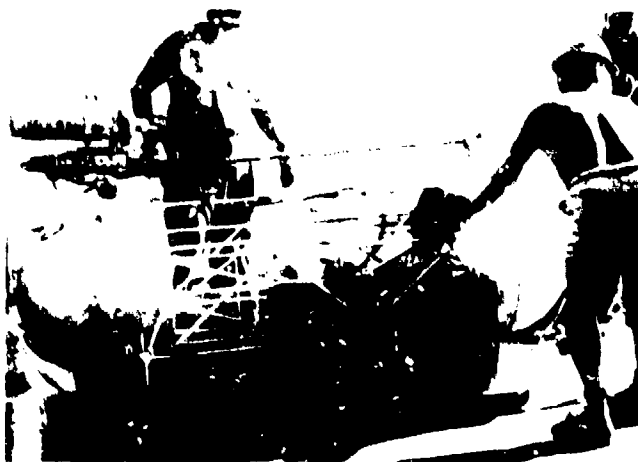
(U) Fig. 14 — Pair of mechanical cable terminations (held by man at left), a hydrophone in a vibration-isolation cage, and (upper left) an electronics package

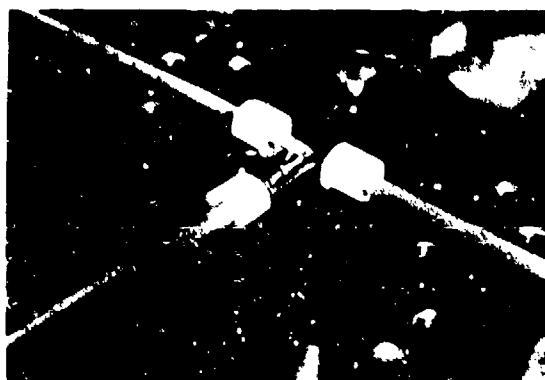
(a) Splice (with fuse) before molding

(b) Splice after molding

(U) Fig. 15 - Improved mold splicing technique

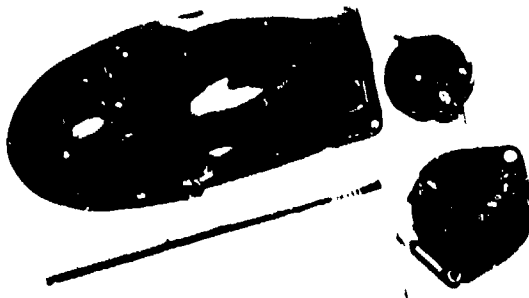
(U) Fig. 16 — Polyethylene-jacketed buoyancy elements in comparison to a yardstick. A wire-rope tether and nylon cable grip is attached to the 16-inch sphere. The two 10-inch spheres are identical.

(U) The 16-inch spheres were housed in polyethylene teardrop-shaped enclosures (Fig. 16) with fins to orient them into the current. Tests indicated that this substantially decreased their hydrodynamic drag coefficient. To provide free orientation without fouling the array cable, it was necessary to provide a flexible steel pendant between these spheres and the cable. On the cable was a nylon-strap thrust collar which was free to rotate to relieve any twists which occurred during array deployment. This 16-inch-sphere attachment could be quickly riveted to the cable (Fig. 17), but the attachment proved unsatisfactory during implantment, because wave action and the motion of the moor near the surface twisted the spheres and their 1/8-inch-diameter wire-rope pendants to the point where many spheres broke loose.

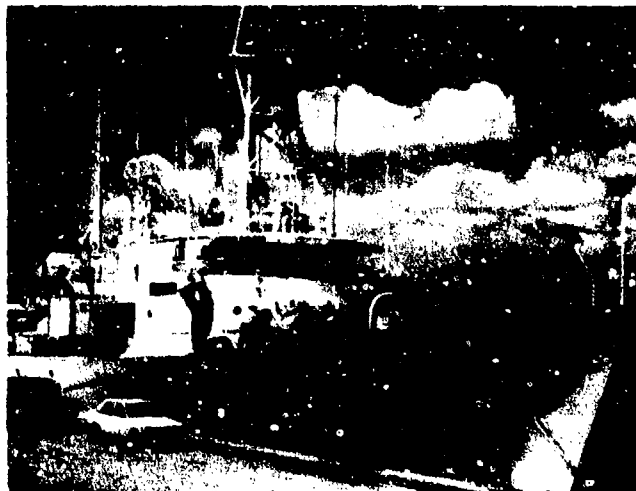
(U) Fig. 26 — The USNS *Sands*, the navigation and signal-monitoring vessel. The diver compression chamber is just forward of the deckhouse.

(U) The *Rigbuilder* was an excellent ship for the type of implantment, though cramped for stowage and berthing space for this project. To offset these minimal facilities, certain equipment was carried aboard the primary navigation and signal monitoring vessel, USNS *Sands* (AGOR-6). For example it was necessary to mount the diver decompression chamber on her foredeck because of space limitations. The *Sands* (Fig. 26) was an oceanographic research vessel assigned to the Naval Underwater Systems Center, New London Laboratory, which was then known as the Naval Underwater Sound Laboratory. The *Sands* had installed in her hull suitable sonar equipment for acoustic ocean-bottom navigation from transponders and a satellite navigator for surface navigation. In her laboratory Sea Spider electronic receiving and computing equipment was installed to monitor the array. Upon array deployment she was to remain as the monitor ship for 2 weeks, after which she would have been relieved by another vessel.

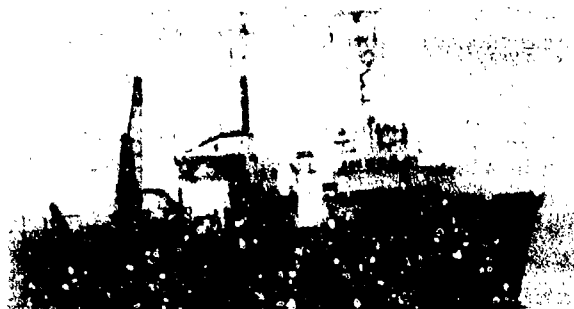
(U) Fig. 27 — Research vessel *Robert D. Conrad*, which assisted during the second implantment attempt

(U) During the second implantment attempt the research vessel *Conrad* (Fig. 27) assigned by the Navy to Columbia University, assisted in providing continuous surface navigation data between the marker buoy at moor center and the *Rigbuilder*. In addition, she also berthed overflow personnel and provided deck force assistance during deployment.

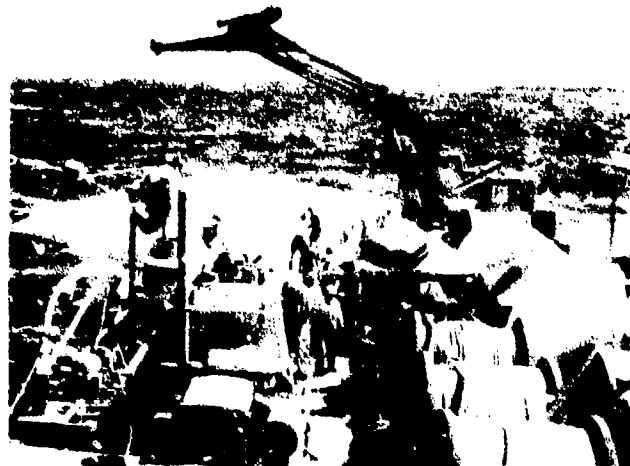
(U) Fig. 35 — Retrieval of the surface float in rough seas upon failure of the first implantment attempt

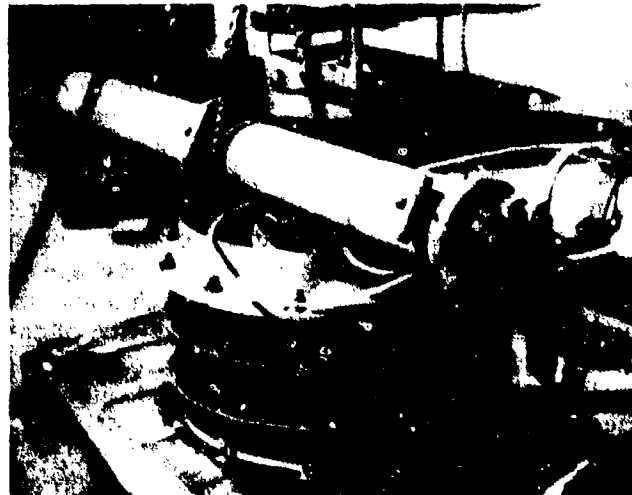
(U) Fig. 37 — One of the three acoustic projectors for locating the bottoms of the three legs. The long cylinder atop the projector houses its electronics package and an explosive anchor-release.

(U) Deployment of the northeast-leg anchor started at 1900 and was completed 5 hours later. One hydrophone failed shortly after deployment of the leg, and the projector (Fig. 37) failed a few hours after the anchor reached the bottom. The time of this event is not known with certainty, but it occurred during the 24 hours after touch-down of the anchor. The projector failure was found afterward to be caused by a few ounces of water penetrating the seal of the electronic pressure housing; the same leak caused the explosive anchor release to fire, thus releasing the anchor.
